NEW MEXICO ENVIRONMENT DEPARTMENT

Re: Las Cruces International Airport / Las Cruces International Airport; MSGP; SIC 4581; NPDES Compliance Evaluation Inspection; NPDES# NMR053390; May 2, 2018

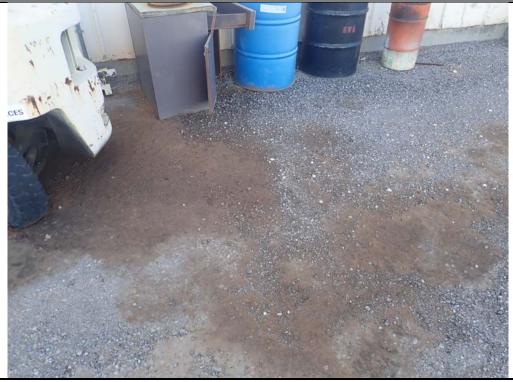
NMED/SWQ Official Photograp Photo # 1			
Photographer: Jennifer Foote	Date: 5/3/18	Time: 7:27 am		
City/County: Las Cruces/Dona Ana State: New Mexico				
Location: Las Cruces International Airport				
Subject: Leaks and drum storage at Southwest Aviation

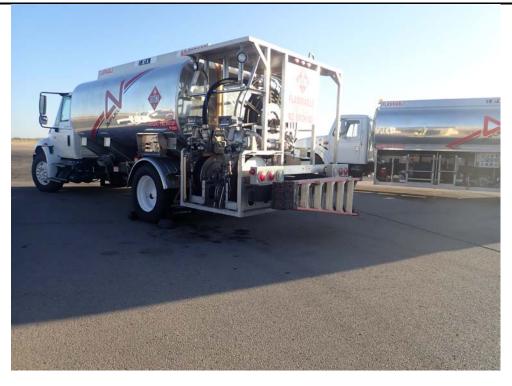
NMED/SWQB Official Photograph Log Photo # 2			
Photographer: Jennifer Foote	Date: 5/3/18	Time: 7:20 am	
City/County: Las Cruces/Dona Ana State: New Mexico			
Location: Las Cruces International Airport			
Subject: Leaks under fueling trucks

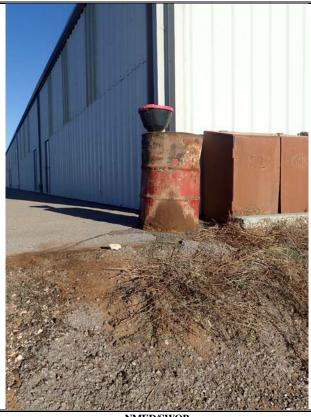
NMED/SWQB Official Photograph Log Photo # 3	3		
Photographer: Jennifer Foote	Date: 5/3/18	Time: 7:37 am		
City/County: Las Cruces/Dona Ana State: New Mexico				
Location: Las Cruces International Airport				
Subject: used oil drum and staining on ground

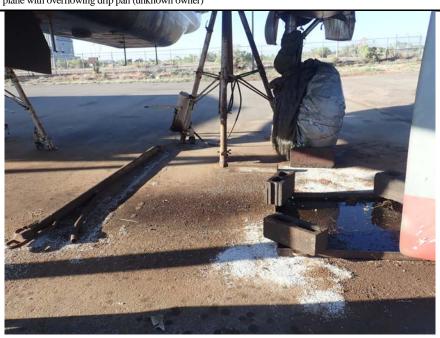
NMED/SWQB Official Photograph Log Photo # 4				
Photographer: Jennifer Foote	Date: 5/3/18	Time: 7:35 am		
City/County: Las Cruces/Dona Ana State: New Mexico				
Location: Las Cruces International Airport				
Subject: long term leak under plane with overflowing drip pan (unknown owner)

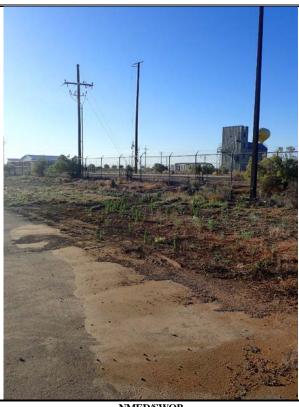
NMED/SWQB Official Photograph Log Photo # 5		
Photographer: Jennifer Foote	Date: 5/3/18	Time: 7:34 am
City/County: Las Cruces/Dona Ana		State: New Mexico
Location: Las Cruces International Airport		
Subject: oil staining from plane near storm drain

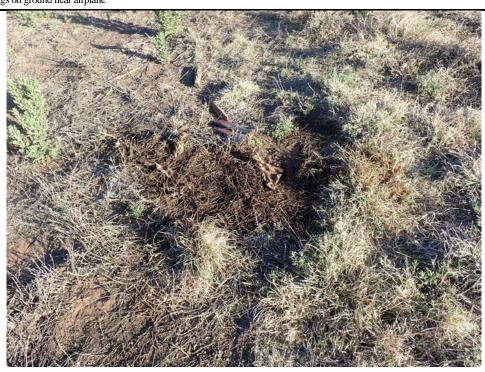
NMED/SWQB Official Photograph L	og
Photo # 6		
Photographer: Jennifer Foote	Date: 5/3/18	Time: 7:33am
City/County: Las Cruces/Dona Ana		State: New Mexico
Location: Las Cruces International Airport		
Subject: oil stain and rags on ground near air	plane

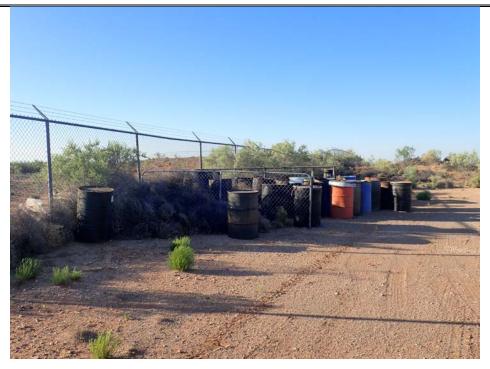
NMED/SWQB Official Photograph Log Photo #8		
Photographer: Jennifer Foote	Date: 5/3/18	Time: 7:41am
City/County: Las Cruces/Dona Ana		State: New Mexico
Location: Las Cruces International Airpor	t	•
Subject: drum storage area

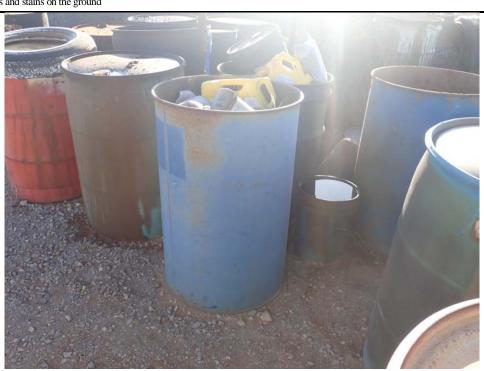
NMED/SWQB Official Photograph Log Photo # 9		
Photographer: Jennifer Foote	Date: 5/3/18	Time: 7:41am
City/County: Las Cruces/Dona Ana		State: New Mexico
Location: Las Cruces International Airport		
Subject: open containers and stains on the ground

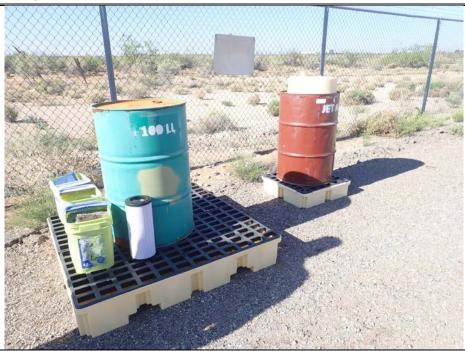
NMED/SWQB Official Photograph Log Photo # 10			
Photographer: Jennifer Foote	Date: 5/3/18	Time: 8:56am	
City/County: Las Cruces/Dona Ana		State: New Mexico	
Location: Las Cruces International Airport			
Subject: drum storage on secondary within ta	nk farm

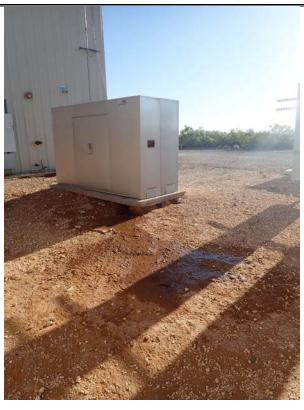
NMED/SWQB Official Photograph I Photo # 11	og
Photographer: Jennifer Foote	Date: 5/3/18	Time: 8 am
City/County: Las Cruces/Dona Ana		State: New Mexico
Location: Las Cruces International Airport		
Subject: water leaking from outdoor equipment

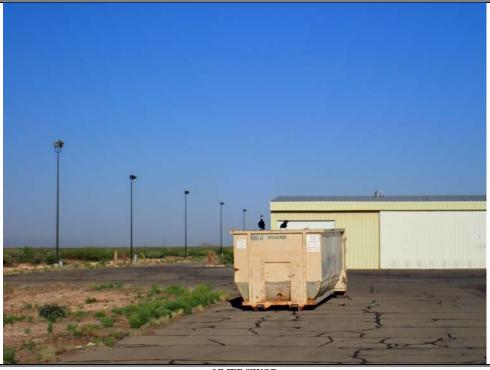
NMED/SWQB Official Photograph Log Photo # 12			
Photographer: Jennifer Foote	Date: 5/3/18	Time: 7:48am	
City/County: Las Cruces/Dona Ana		State: New Mexico	
Location: Las Cruces International Airport			
Subject: uncovered dumpsters

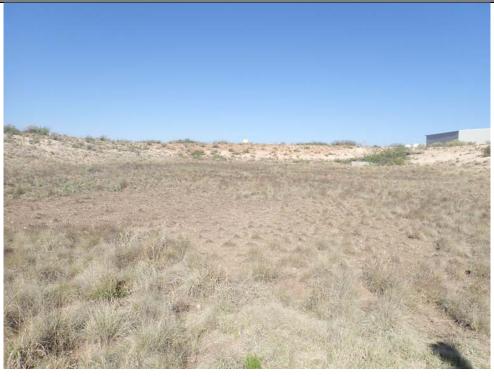
SWPPP Implementation	on .
Spill Prevention and Response	(e.g., minimizing the potential for leaks, spills and other releases that may be exposed to storm water and develop plans for effective response to such spills if or when they occur)
	Several items of equipment and drums were leaking, photos 1-9. Staff stated they were trying to determine owners of the leaking plane.
	The aboveground storage tanks had adequate secondary containment and a spill kit was available. Two drums within the fence were labeled and on secondary containment (photo 10). However, other another drum had signs of seepage and was not on containment.
Erosion and Sediment Controls	(e.g., stabilize exposed areas and contain runoff using structural and/or non-structural control measures to minimize onsite erosion and sedimentation, flow velocity dissipation devices at discharge locations and within outfall channels)
	Majority of facility is paved with storm drains leading to a vegetated retention pond (photo 13).

NMED/SWQB Official Photograph Log Photo # 13		
Photographer: Jennifer Foote	Date: 5/3/18	Time: 9:05am
City/County: Las Cruces/Dona Ana		State: New Mexico
Location: Las Cruces International Airport		
Subject: drainage pond with no outlet
